SIO Shipyard Representative Bi-Weekly Progress Report		
Project: AGOR 28	Contract No.: N00014-12-C-0305	Shipyard: Dakota Creek Industries
Prepared by: Paul D. Bueren Scripps Institution of Oceanography (SIO) 297 Rosecrans St. San Diego, CA 98106	Date: 22 April 2016	Program Officer: Robert (Tim) Schnoor Office of Naval Research 875 Randolph St ONR 321 Arlington, VA 22203-1995
Distribution Statement A: Approved for public release; distribution unlimited.		Report No. A002.098

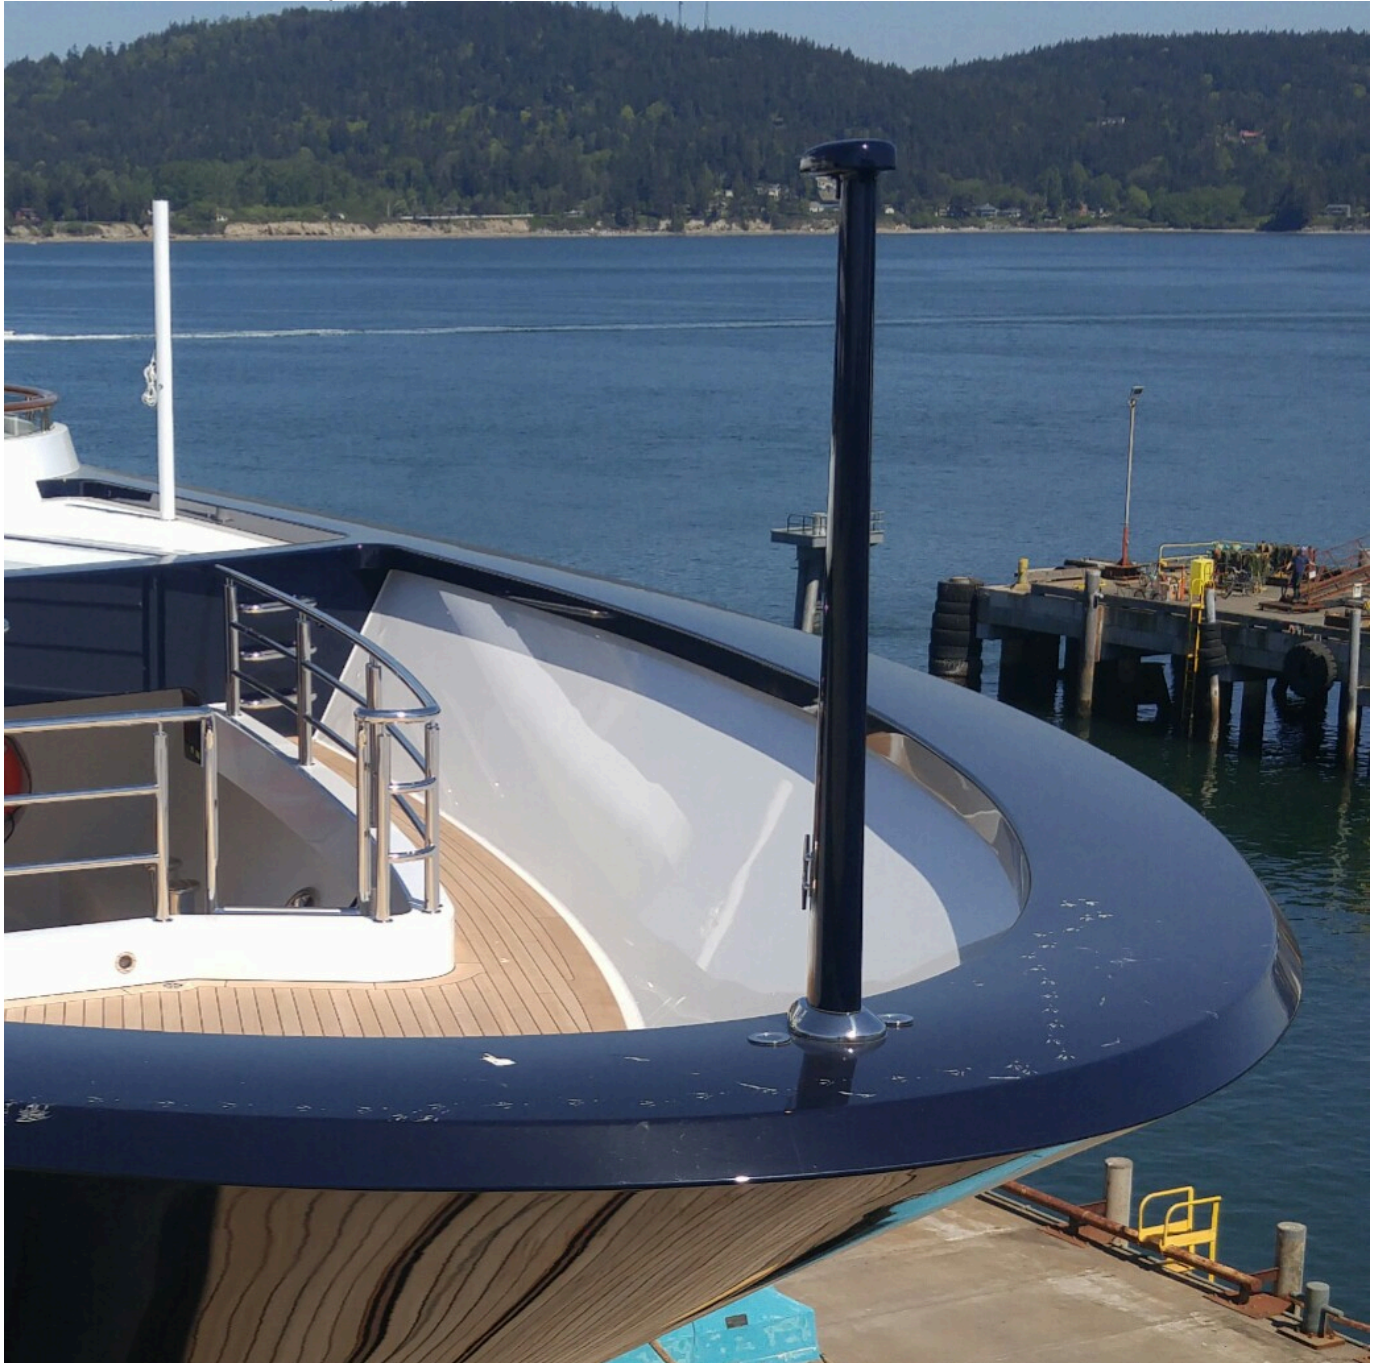
When a bird lands on wet paint and then walks across your \$2 million paint job... The Motor Yacht Albatross parked behind Ride
